DATA COLLECTION REPORT

PART ONE - GENERAL INFORMATION
CHAPTER 3 - DATA COLLECTION REPORT

Higginbotham & Assoc
April 1987

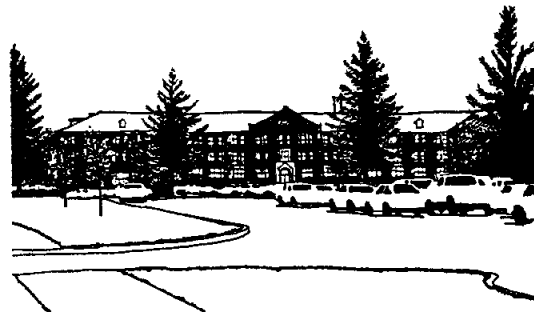
Fig F-3-A

Georgian Colonial Revival Garrison Area Headquarters and Barracks buildings.

Red brick with white-painted wood trim.

World War II wood frame buildings-monotonous appearance.

Crowded building elements; poor massing; flat roofs.

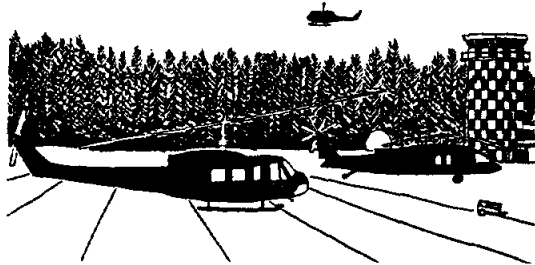
Fig F-3-B

Scale, materials and detailing of Flight Simulator building.

Utilitarian appearances with no visual amenities.

Wall materials; low-slope roof pitch.

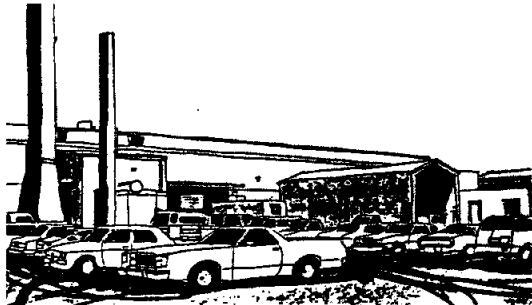
Fig F-3-C

Garrison Area Motor Pool buildings have consistent use of materials; red brick, white-painted trim, gable tile roofs.

Large, stark, plain building masses; no detailing.

Random placement of buildings.

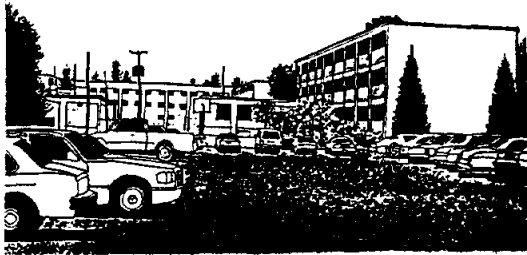
Fig F-3-D

Quality design and materials of Garrison Area Barracks.

Dispersed Industrial Style barracks lack pitched roofs, defined entrances and architectural details to give them human scale.

Barracks grouped around courtyards of open space or around mess halls.

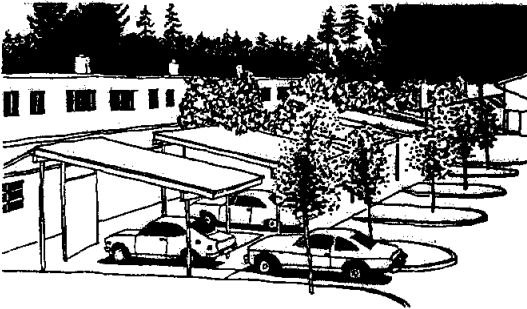
Fig F-3-E

Broadmoor Housing appears quiet and dignified.

Attached housing areas built during the Dispersed Industrial Period utilize regular residential building materials and have gable roofs.

Outmoded styling, repetitive models and unappealing colors; inadequate maintenance of wood siding.

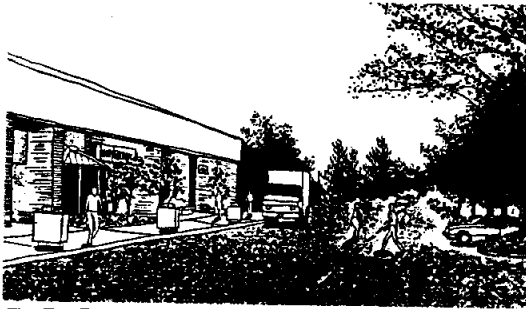
Fig F-3-F

Quality materials such as red tiled gable roofs, red brick, stone accents and careful detailing used on one and two-story buildings such as the Main Post Chapel.

Utilitarian designs which have no visual amenities to their exteriors; they have limited fenestration, an absence of ornamentation, flat facades with no modulation, a lack of texture, no rhythm of repetitive features, etc.

Strip development of buildings which face onto giant parking lot; no entrance to Community Center complex.

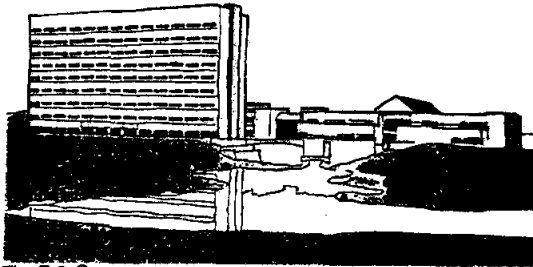
Fig F-3-G

Strong relationship of red brick buildings to each other and higher quality of materials create a sense of permanence and stability.

Traditional style, pitched roofs, wood windows and white-painted wood trim and foundations present a pleasant appearance.

Design details, decorative wood railing, parapets and cupolas add visual interest.

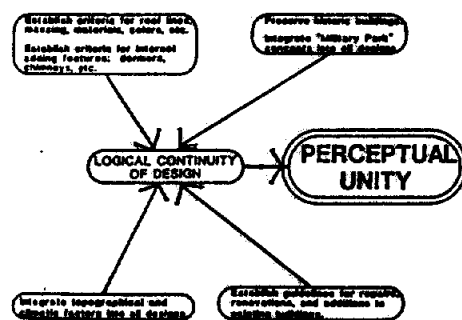
Fig F-3-I

The Architectural Design Goal for Fort Lewis is to establish a systematic and consistent approach to the use of materials, scale and color in order to bring into being a logical continuity of design, both historically and functionally, that will result in an overall sense of perceptual unity (Fig. F-3-I).

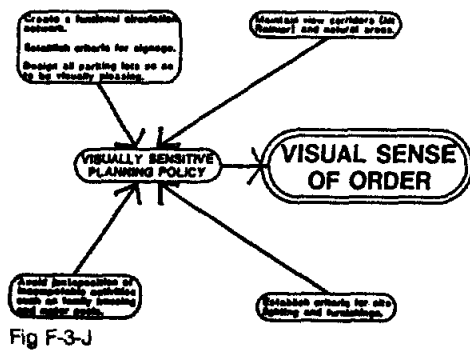
Creating a visual sense of order, strengthening a visitor's first impression of the overall installation and giving it meaningful content, defining a well planned circulation network, screening the less desirable sights, and coordinating the organizational details of site furnishings, lighting and utilities are ideas which, taken together, constitute the Planning Design Goal of this project and which will enhance an individual's comprehension of the installation (Fig F-3-J).

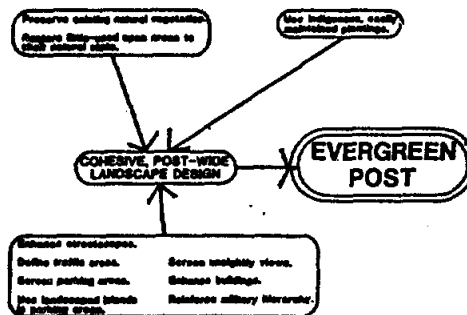
The Landscape Design Goal is to return the "green" to Fort Lewis, once known as the Evergreen Post, by preserving and enhancing existing natural landscape, arranging plant masses in relation to the function and prominence of each facility, and using easily maintained materials, thus creating a cohesive postwide landscape design which emphasizes the view of distant Mt Rainier whenever possible (Fig. F-3-K).

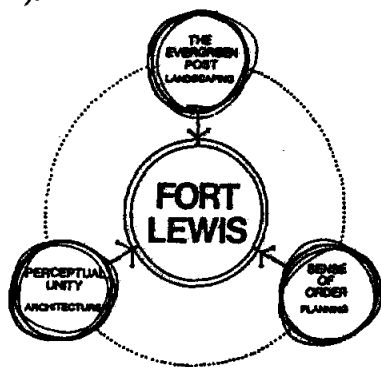
Fig F-3-L

Bold, corrective measures must be taken now in the areas of Architecture, Planning and Landscaping if Fort Lewis is to become a visually desirable place to work and to live. This is in keeping with the goals of the excellent program of the Installation Design Guide. This is a critical point in time; it is still possible to return the Fort to its natural state of green (Fig F-3-L).
